NASA CONTRACTOR REPORT CR-166044

**SHUTTLE ENTRY AIR DATA SYSTEM
(SEADS)
HARDWARE DEVELOPMENT
VOLUME II, HISTORY**

**PREPARED UNDER
CONTRACT NAS1-16000**

**PREPARED BY
D. M. WHILE
VOUGHT CORPORATION
DALLAS, TEXAS**

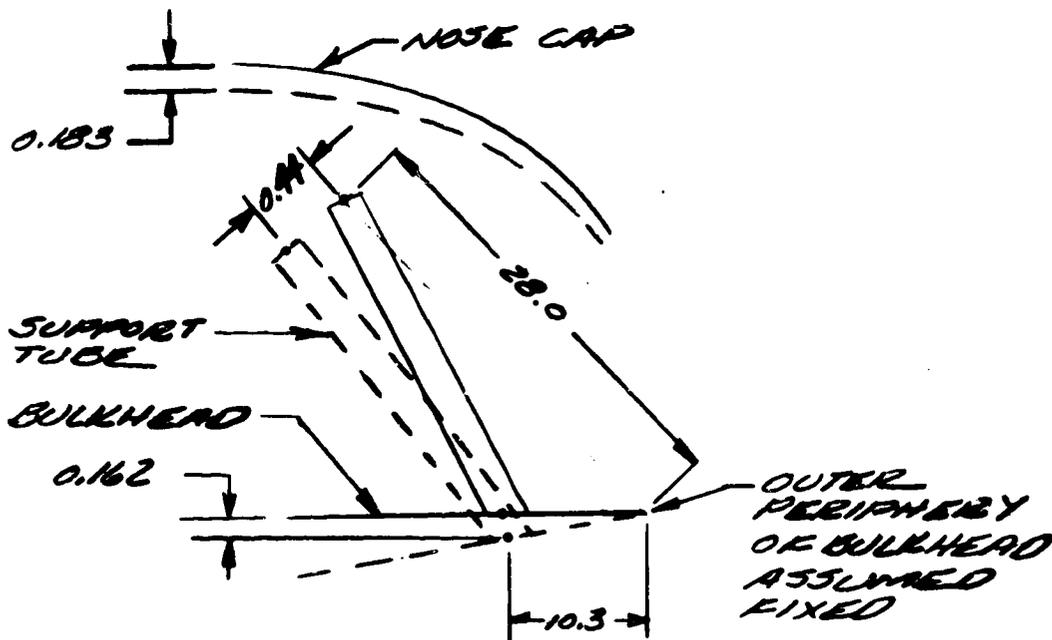
Since the support tubes attach between fittings 2 and 3, and 9 and 10, the average of these deflections was used to calculate tube rotation. The motions used in the deflection analysis are shown as follows:

Using a full scale layout, it was found that the forced deflection for the longest tube was 0.28 inch, while that for the shortest would be 0.25 inch, the difference being due to their location on the nose cap. For this preliminary evaluation the long tube was actually analyzed for 0.3 inch deflection. As noted in the picture above, the outer periphery of the bulkhead was assumed fixed. A deflecting bulkhead boundary was also examined based upon spring rates supplied by Rockwell. This resulted in a 15% reduction in the rotation of the support tube, but the deflections noted above were used because they were documented.

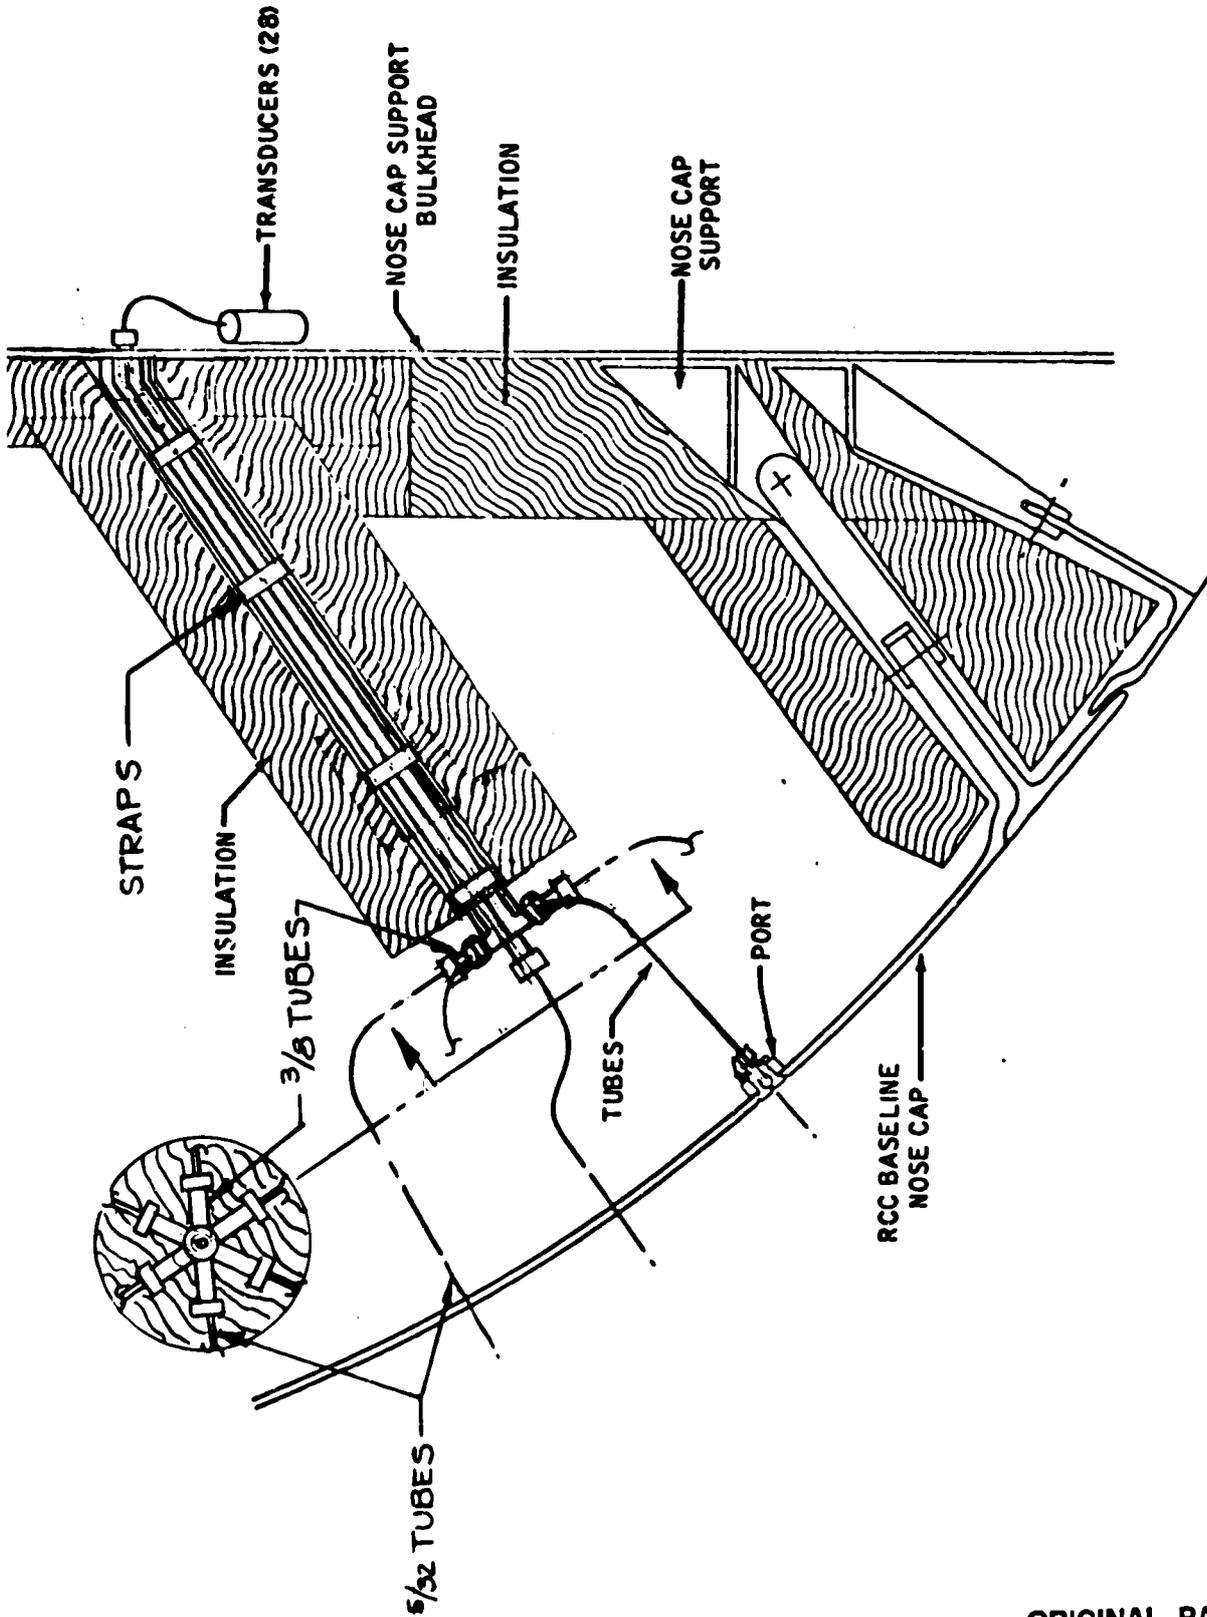
FIGURE 4-30 - GANGED TUBES CONCEPT

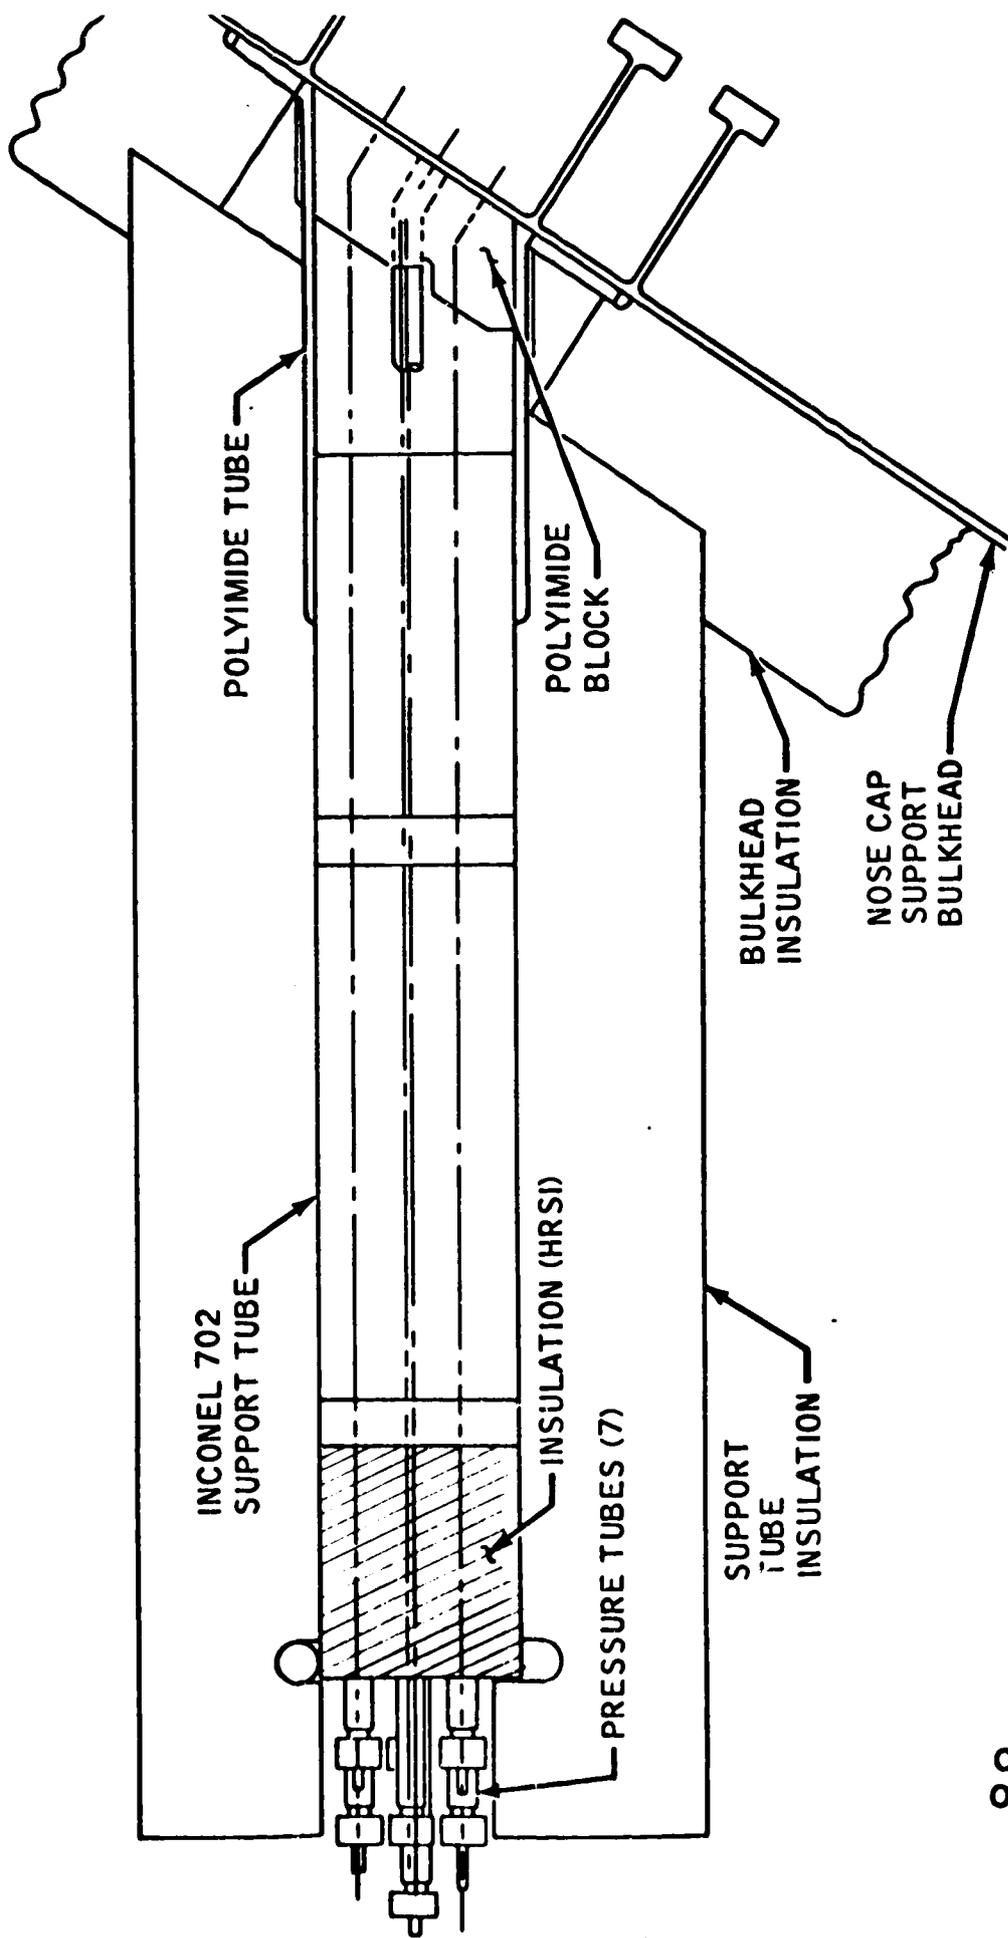
FIGURE 4-32 - SUPPORT TUBE DESIGN

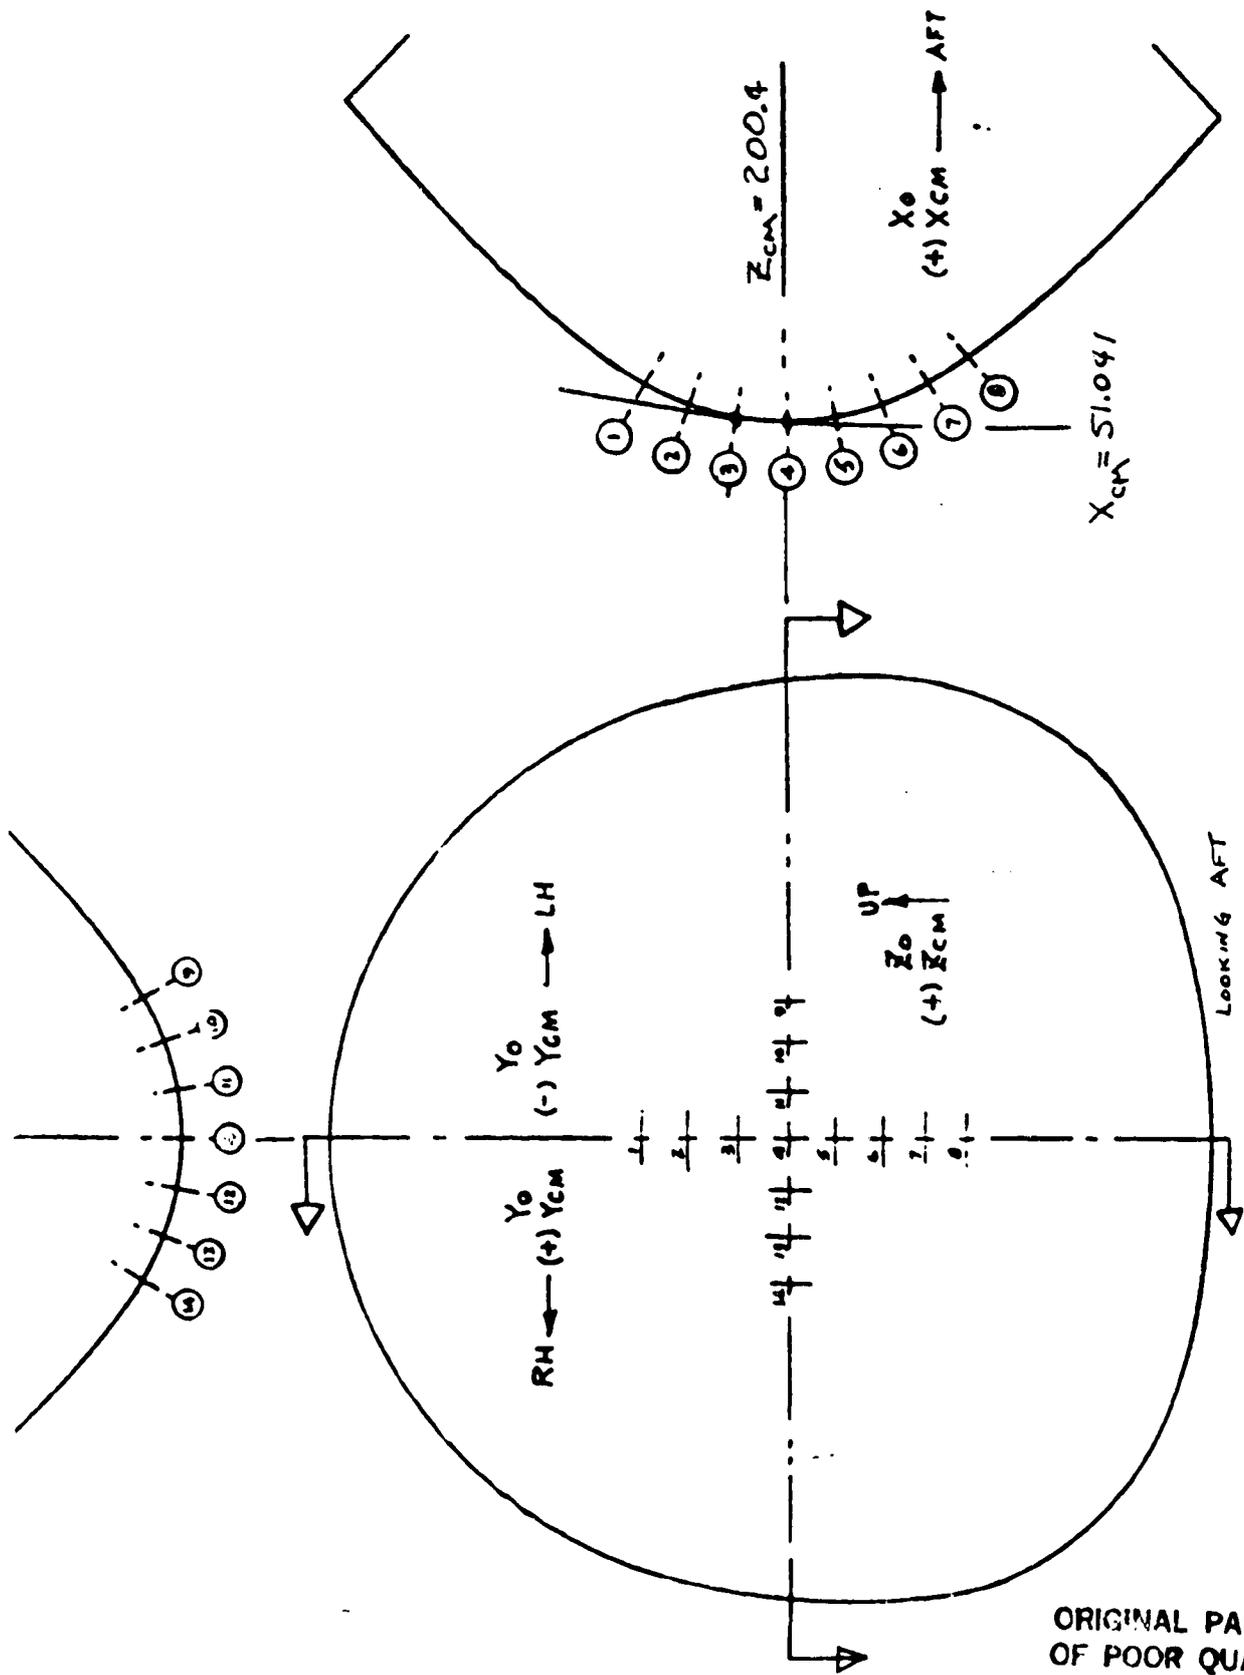
FIGURE 5--1 - SEADS ORIFICE GENERAL ARRANGEMENT

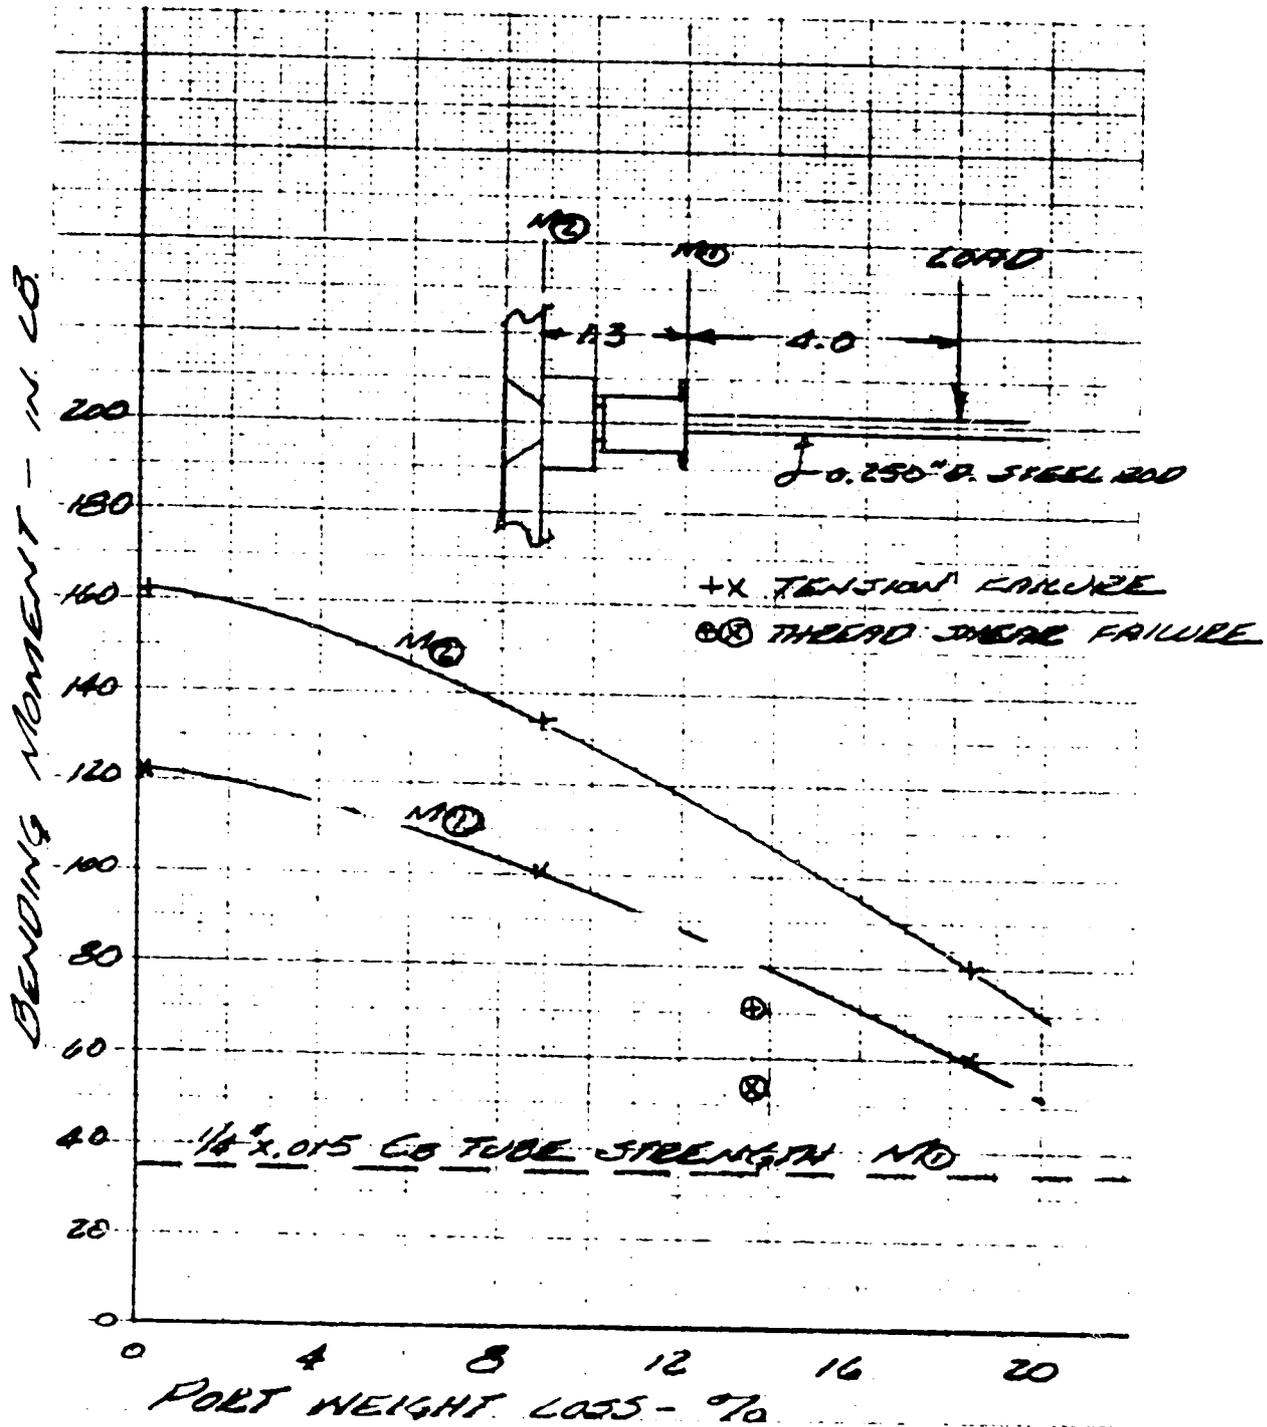
FIGURE 6-3 - GRAPHITE PORT BENDING FAILING LOAD TEST, SERIES 2

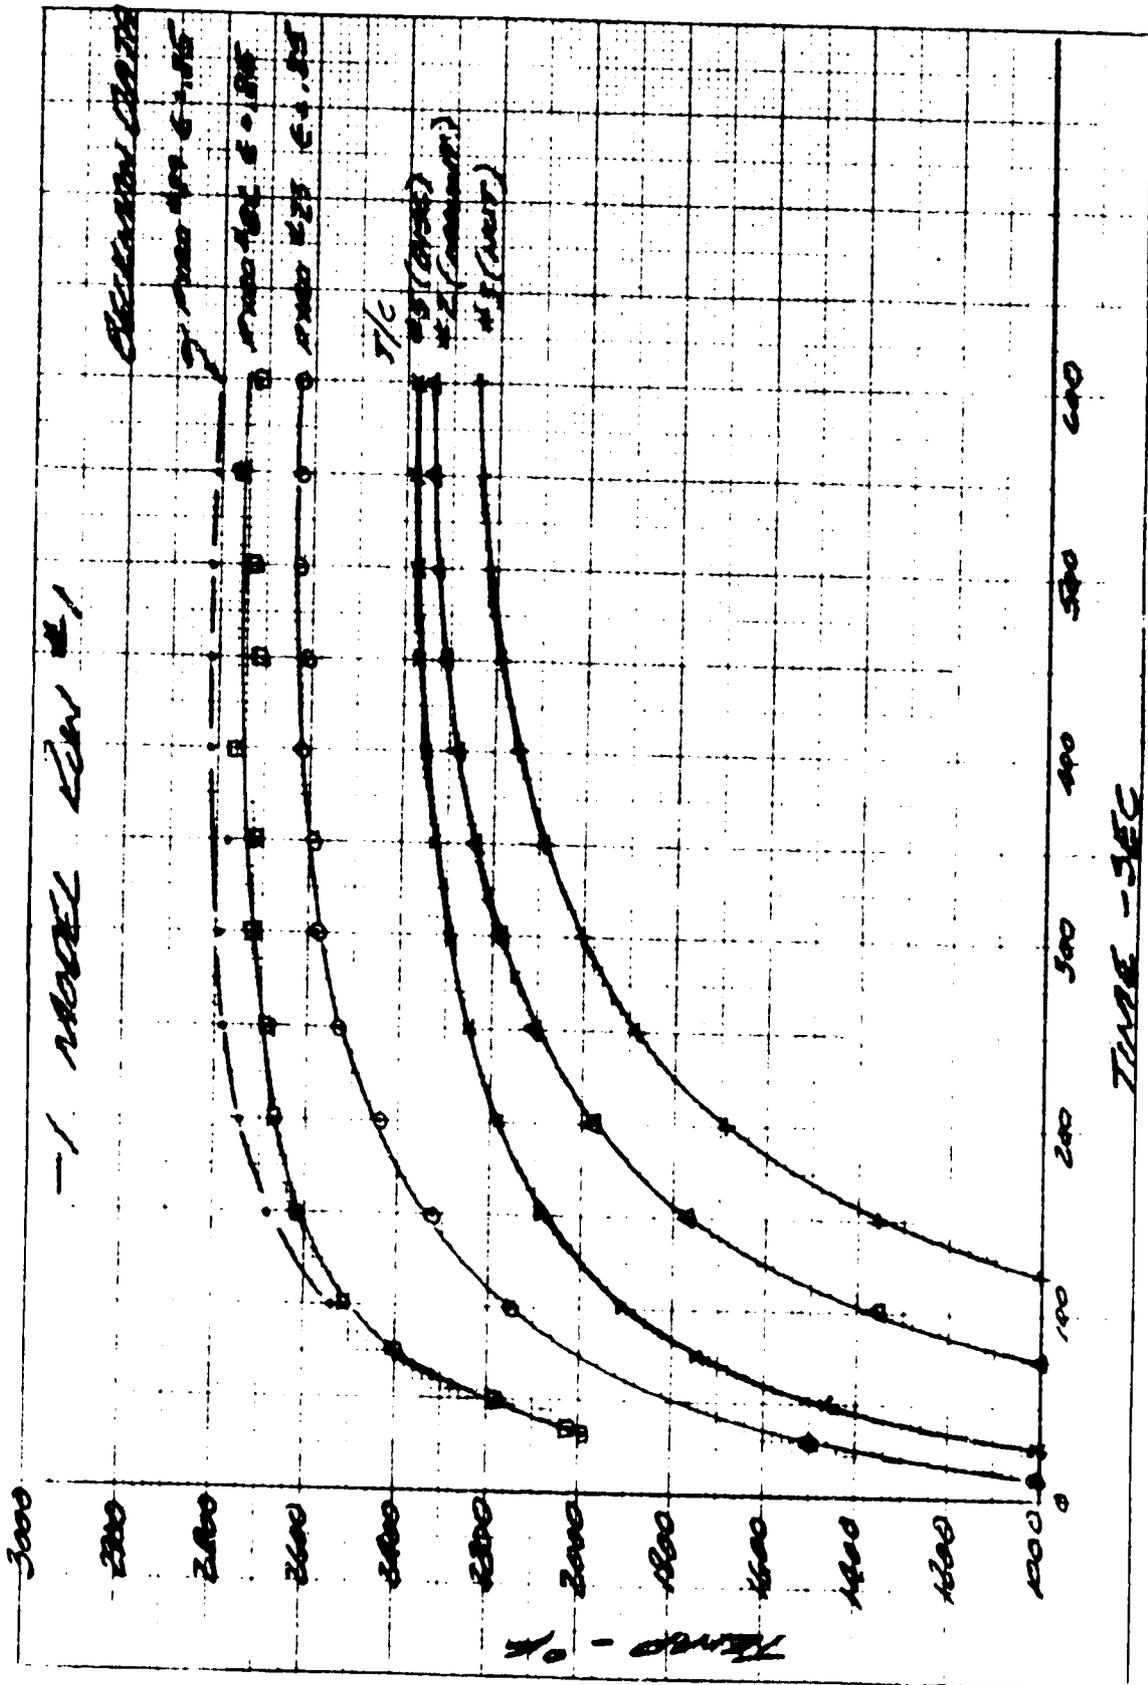
FIGURE 7-20 - TEMPERATURE HISTORY

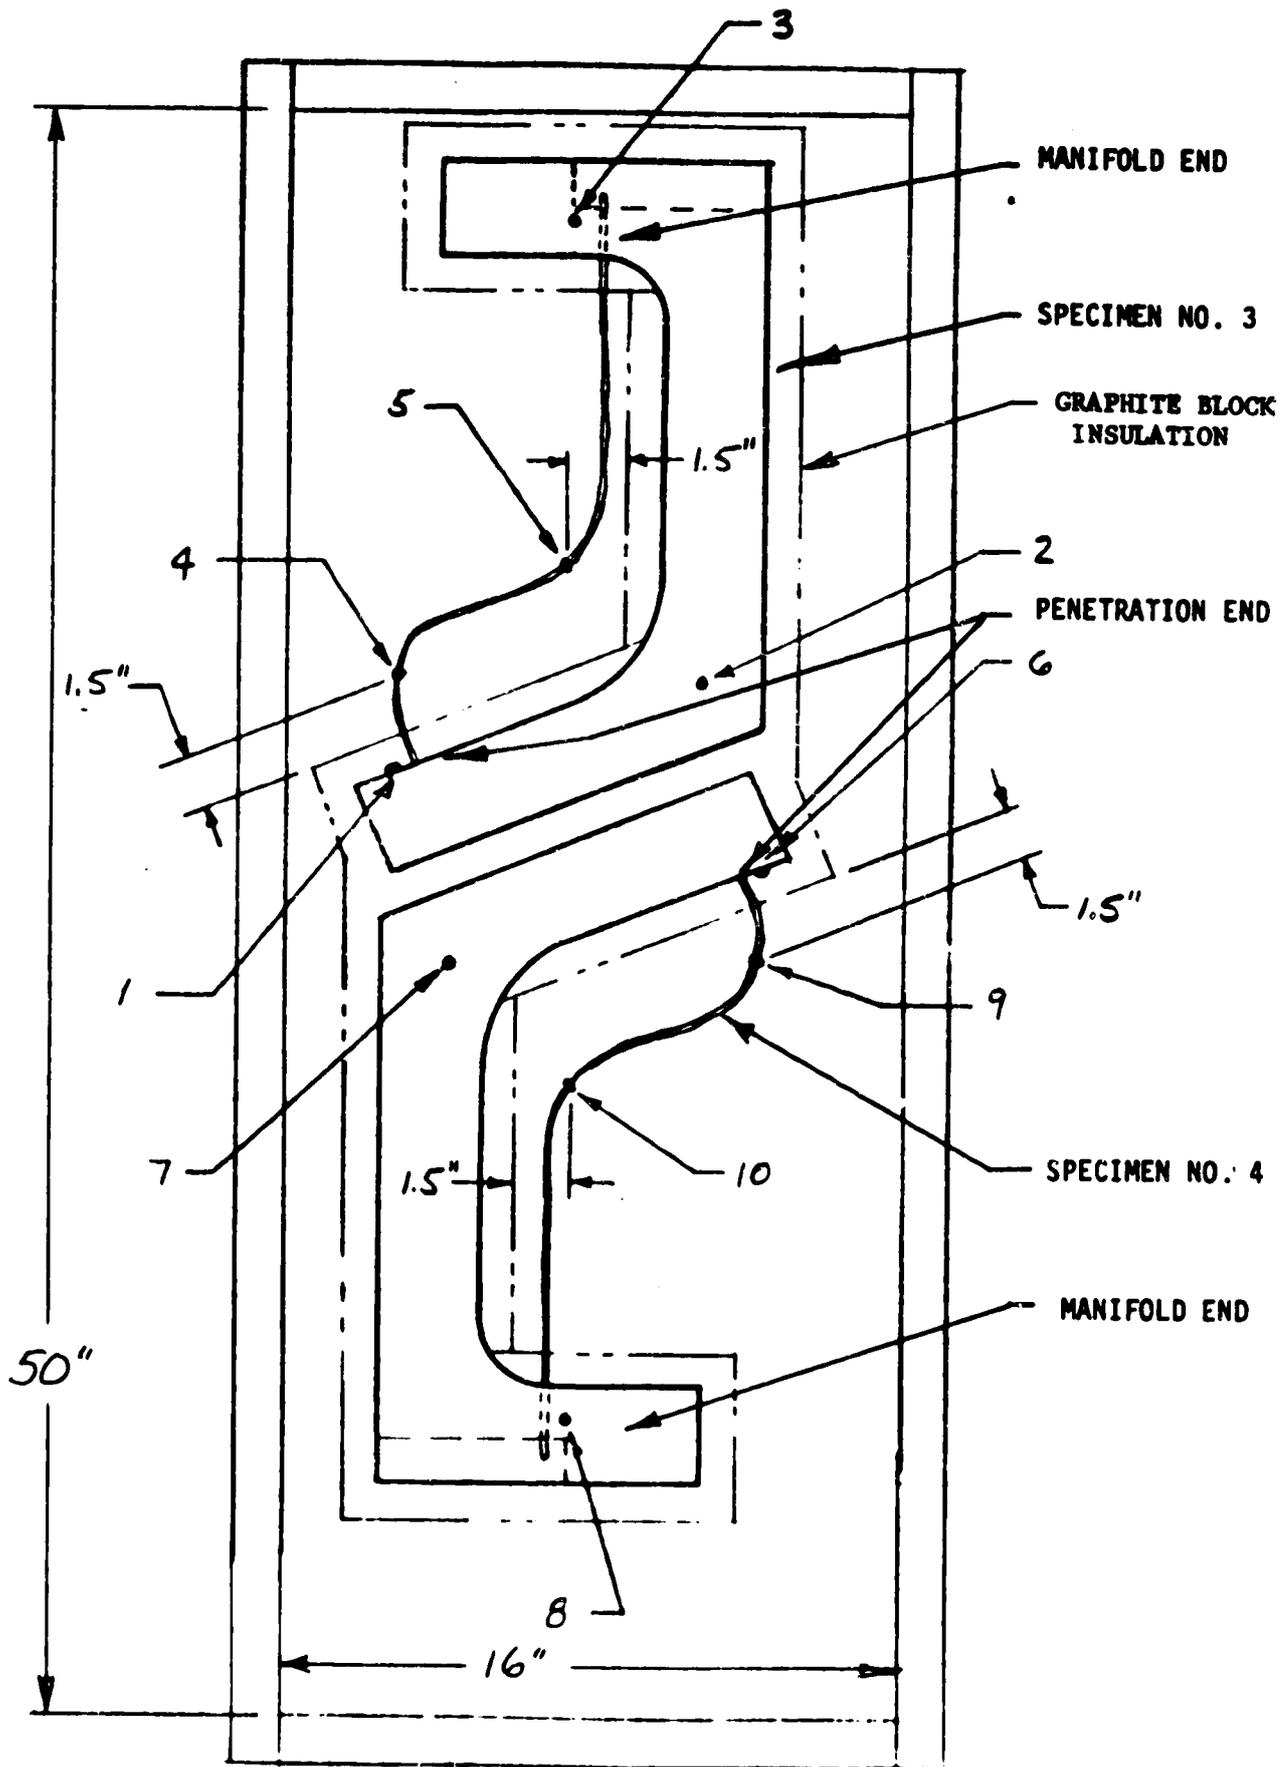
FIGURE 8-5 - THERMAL DEFLECTION TEST OF SEADS PRESSURE TUBES, SPECIMENS NO. 3 & NO. 4 THERMOCOUPLE LOCATIONS

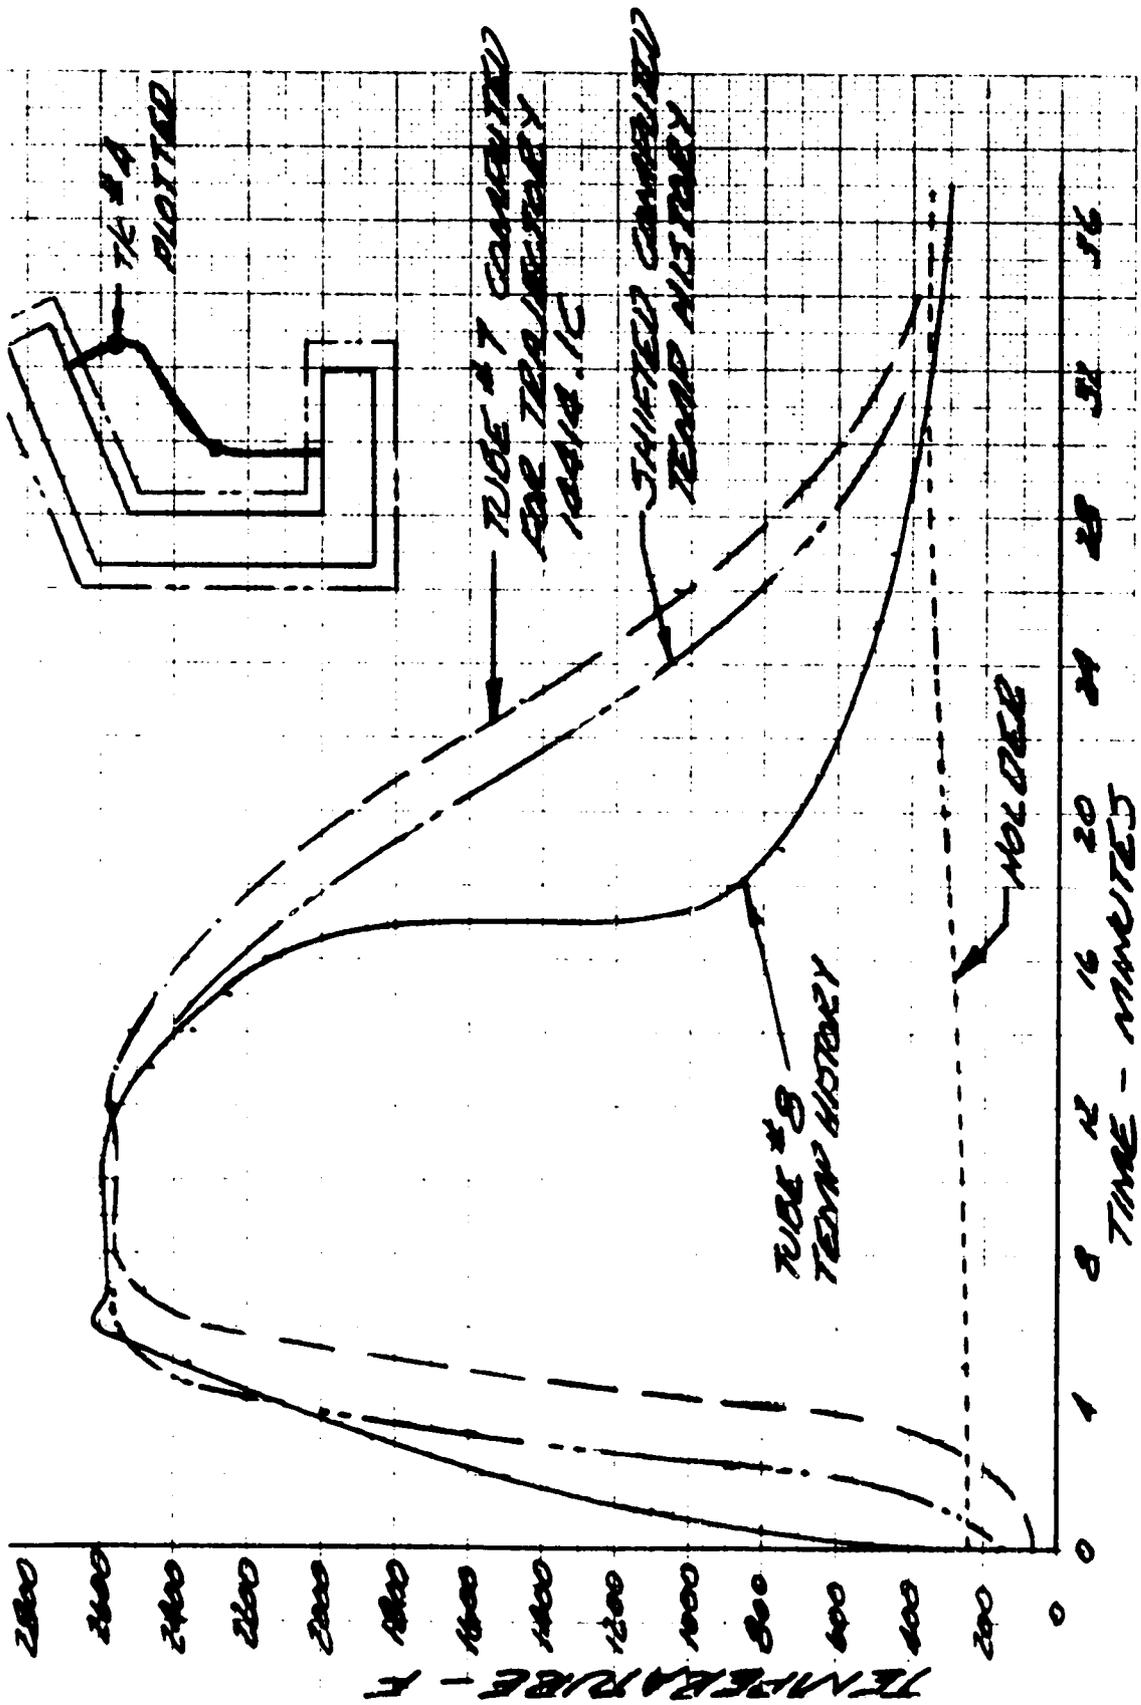
FIGURE 8-6 - TYPICAL THERMAL TEST TEMPERATURE HISTORY

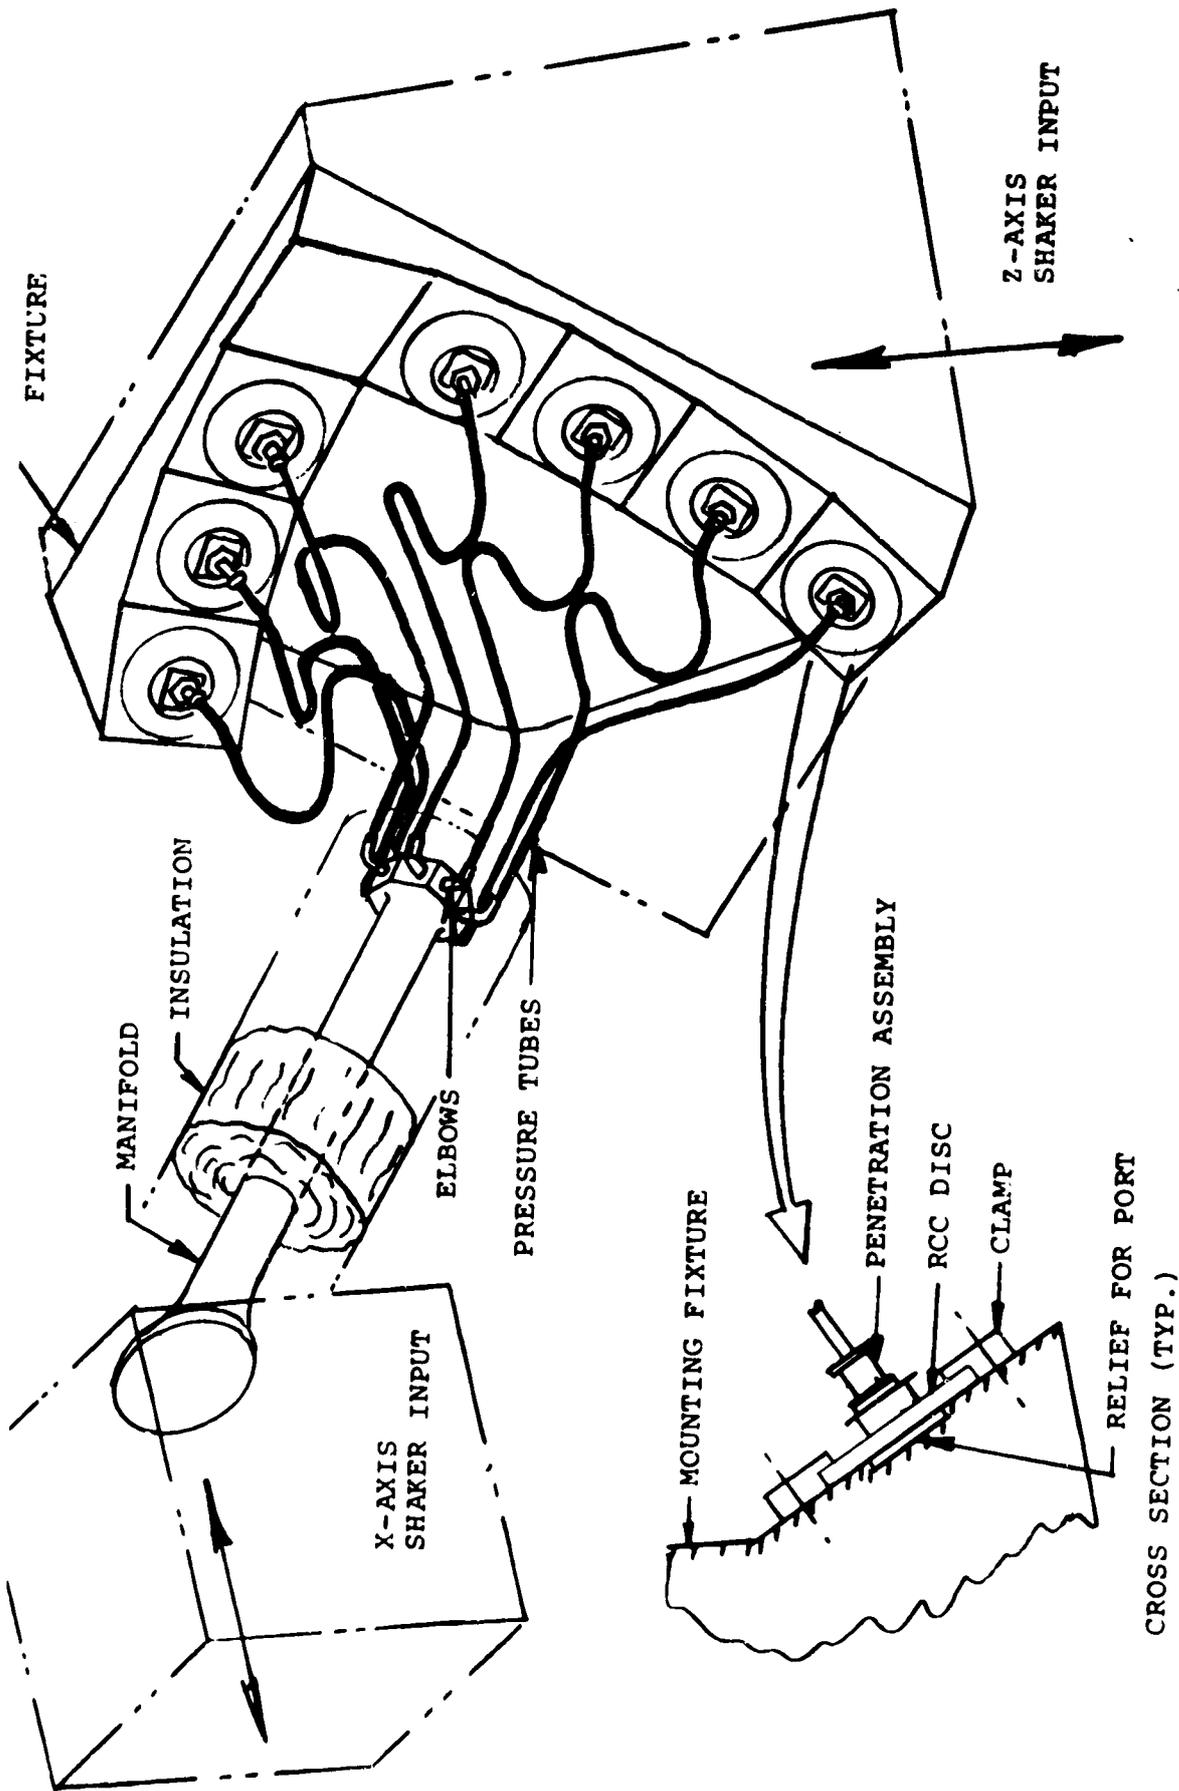
FIGURE 9-1 - VIBRATION TEST CONCEPT

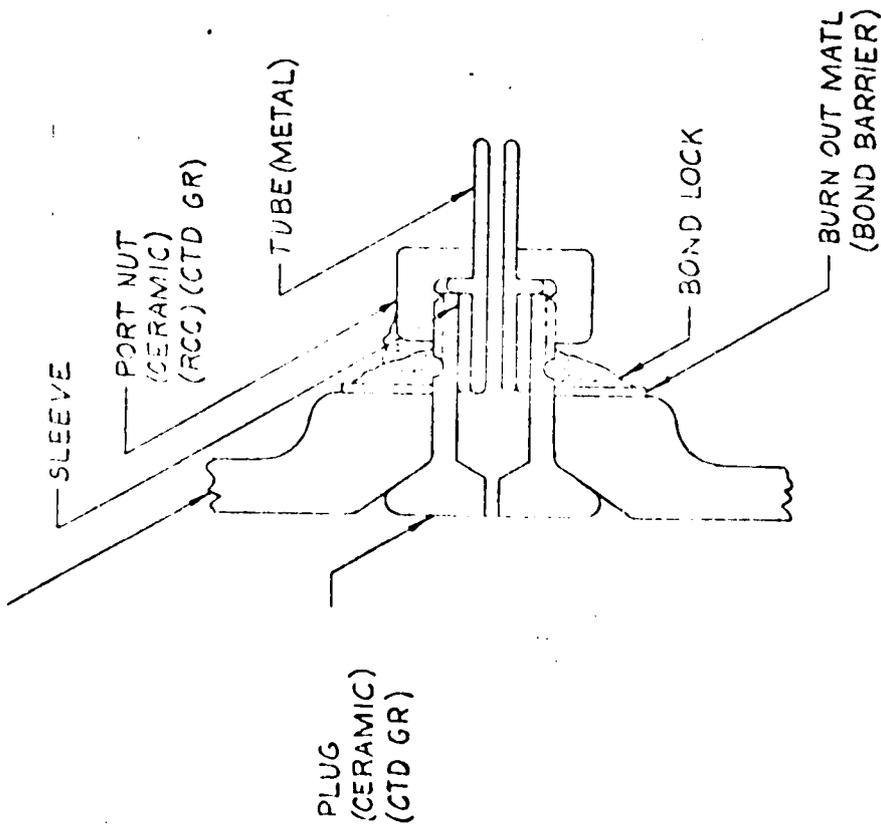
1. BOND FOR LOCK MAY DAMAGE PARTS DURING REPLACEMENT
2. SKIN FEATURE DIFFICULT TO ADJUST TO ACCOMMODATE RCC THICKNESS VARIATIONS
3. LOCKING DEPENDENT ON BOND
4. TUBE FLANGE COULD CAUSE THERMAL EXPANSION PROBLEM WITH COATED CERAMIC, OR RCC NUT
5. NO REDUNDANCY EXCEPT THREAD FOR RETENTION
6. REQUIRES BUILD UP OF ROSE CAP THICKNESS LOCALLY FOR COUNTERBORED RCC; NO PROBLEM WITH COMPENSER
7. PROBABLY DIFFICULT DISASSEMBLY

1. BOND FOR RETENTION BUT THREADS PREVENT TOTAL LOSS
2. EASILY REPLACABLE WITHOUT DAMAGE TO NOSE CAP
3. SOME OVERLAP FOR VIBRATION LOADING
4. BOND MATERIAL LOCKED IN TO PLUG
5. ALLOWS FOR NOSE CAP THICKNESS VARIATIONS

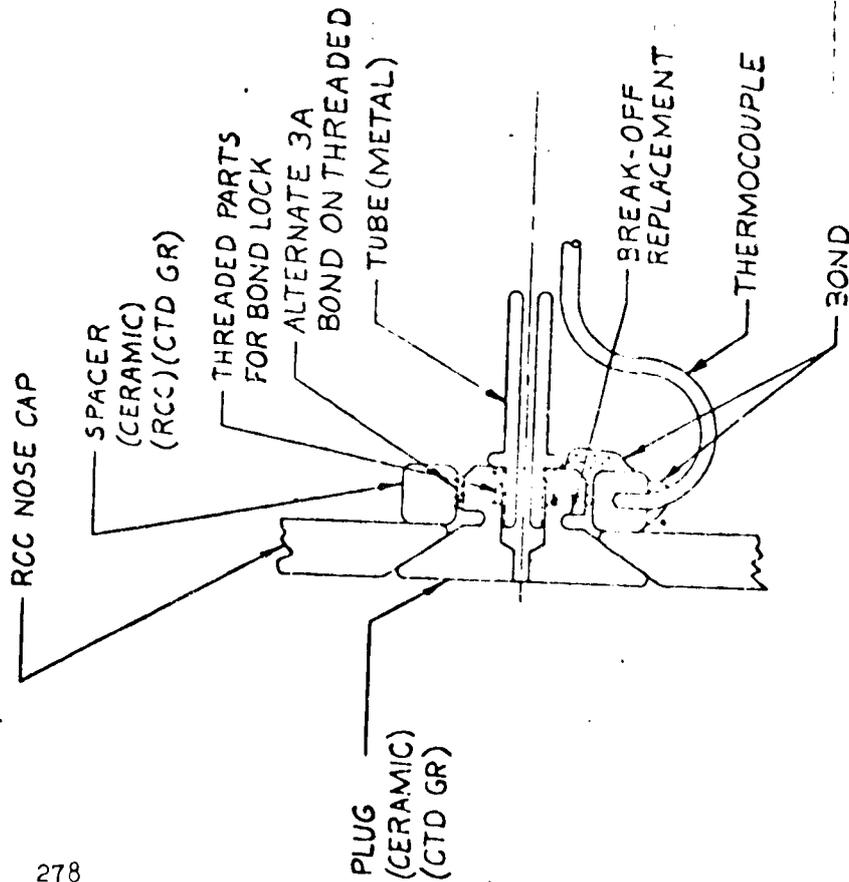
CONCEPT 3f3A

1. BREAK OFF FEATURE FOR EASE OF REPLACEMENT
2. VERY SHORT FOR STRUCTURAL STRENGTH ESPECIALLY UNDER VIBRATION
3. ONLY 2 PARTS
4. READILY ACCOMMODATES THICKNESS VARIATIONS IN RCC

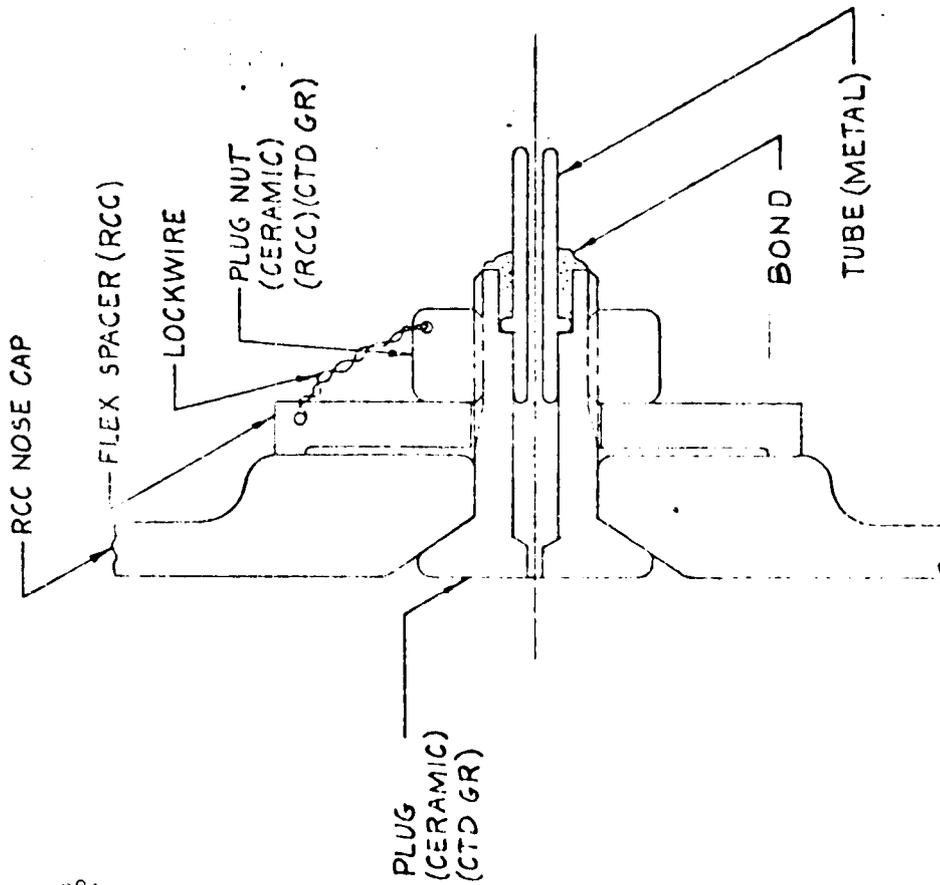
CONCEPT 5

1. ELIMINATES LOOSENESS REQUIRED IN OTHER CONCEPTS FOR THERMAL EXPANSION ACCOMMODATION
2. FLEX WEDGEER DOUBLES AS INSULATOR
3. LARGE PLUG HOLE CONTABLE
4. ACCOMMODATES RCC THICKNESS VARIATIONS
5. EASE OF ASSEMBLY
6. METAL PARTS IN LOWER TEMPERATURE REGION
7. FAIRLY POSITIVE LOCKING FEATURE
